THE NAZZARO COMMUNITY CENTER

BOSTON LANDMARKS COMMISSION

STUDY REPORT

30-32 North Bennet St., Boston, Massachusetts, 02113

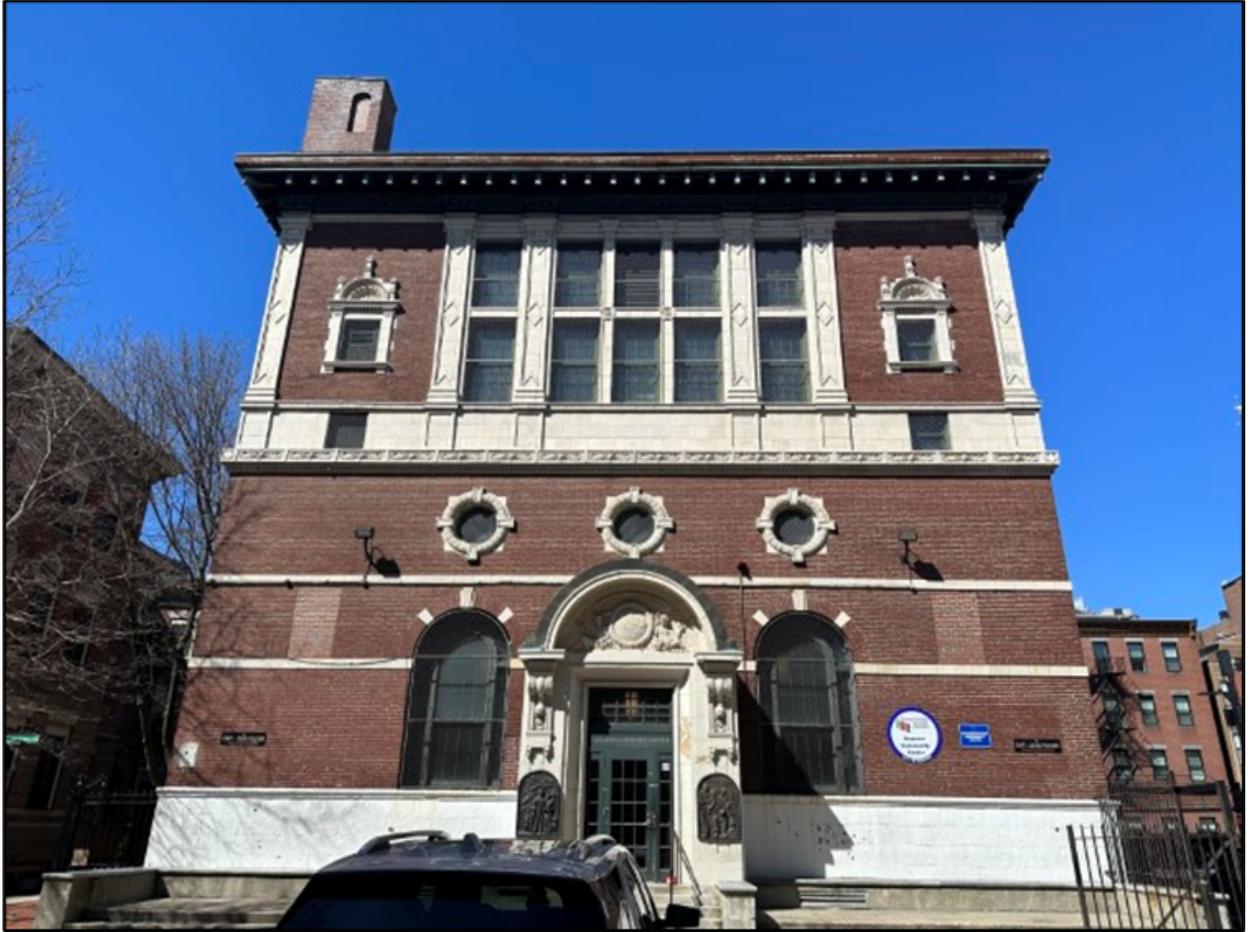
Figure 2. Façade of the Nazzaro Community Center.

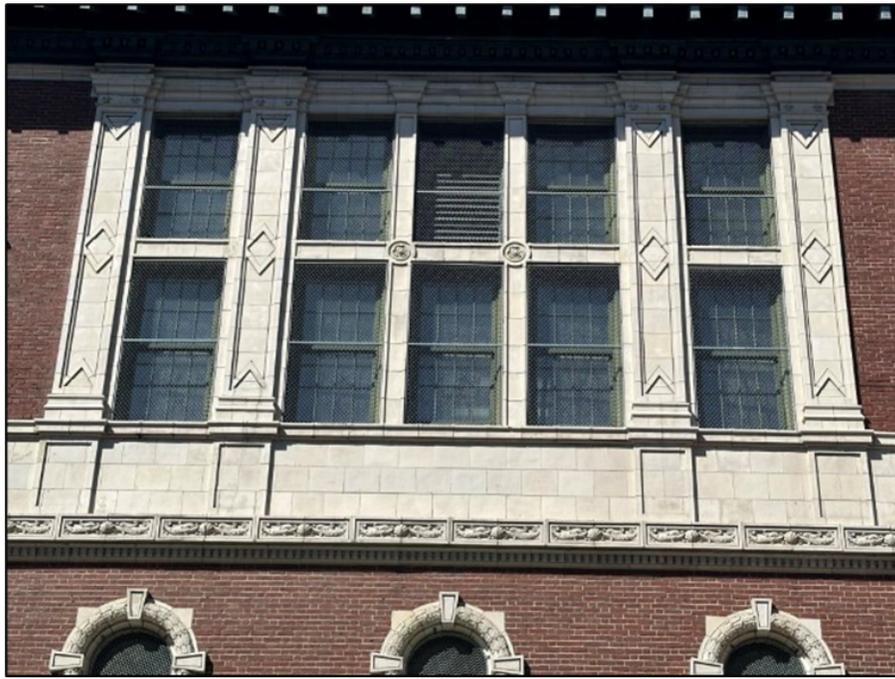
Figure 7. Detail of double rectangular windows on the façade.

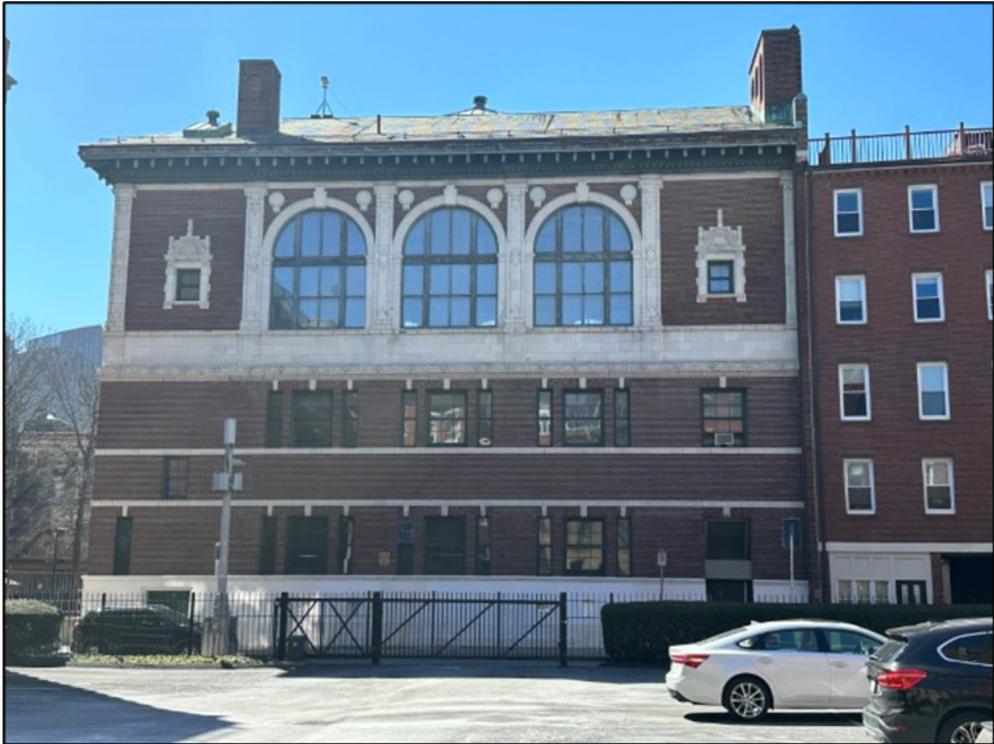
Figure 10. View of northeast elevation at North Bennet Street.

The first floor of the northeast elevation is defined by three sets of identical, coupled-style windows consisting of two vertical two-over-two fixed windows with a flat arch and terra-cotta keystone on either side of a six-over-six sash window with a flat arch and terra-cotta keystone. The original casement windows were replaced with sash windows, most likely during the 1947 update. A single, vertical two-over-two window is located on the left side of the façade. A terra-cotta belt extends across the building above the windows, creating a visual distinction between the first and second floor. Above this a single two-over-two sash window exists on the left side of the building and is bordered above by an additional terra-cotta belt course. This window pattern is repeated on the upper level of the second floor with an additional six-over-six sash window on the right side of the building.

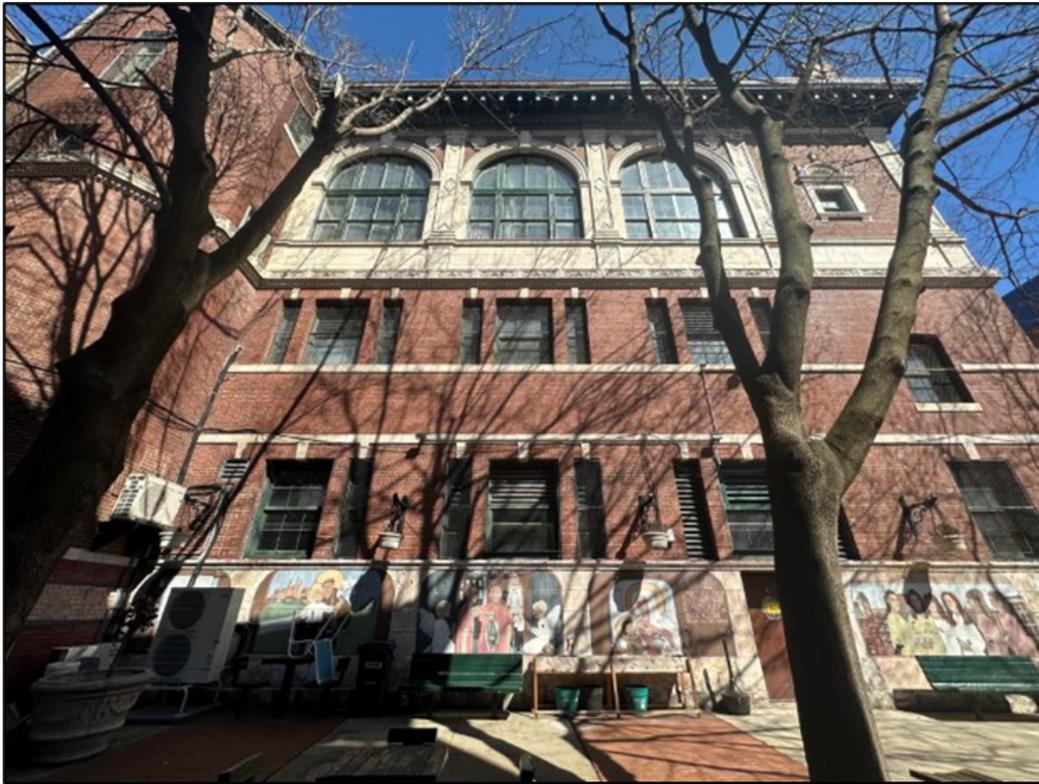
Figure 17. Park-side elevation.

This elevation of the building is called the park side because it opens onto a small park defined by a brick patio and brick walls. The park is named the George “GiGi” Reppucci Garden. This elevation is almost identical to the North Bennet Street (northeast) elevation in structure and ornamentation. The main difference is the tower extending off the back of the elevation. An entrance is located at the raised basement level on the right side. The granite composite blocks with terra-cotta seme glaze have been covered with current-day murals painted by children who frequent the community center. The murals depict religious scenes and motifs. The tower is hexagonal and contains a two-over-two sash window at the second and third stories on the southeast side and four six-over-six sash windows on the southwest side, two at each story, with an entrance at the ground level. Much like the North Bennet Street elevation, the first and second stories of the park-side elevation are defined by three sets of identical coupled-style windows consisting of two vertical two-over-two fixed windows with a flat arch and terra-cotta keystone on either side of a six-over-six sash window with a flat arch and terra-cotta keystone. Each level is defined by a terra-cotta belt course that continues around the tower at the first and third stories. The ornamentation and windows of the third story are identical to those of the North Bennet Street elevation.

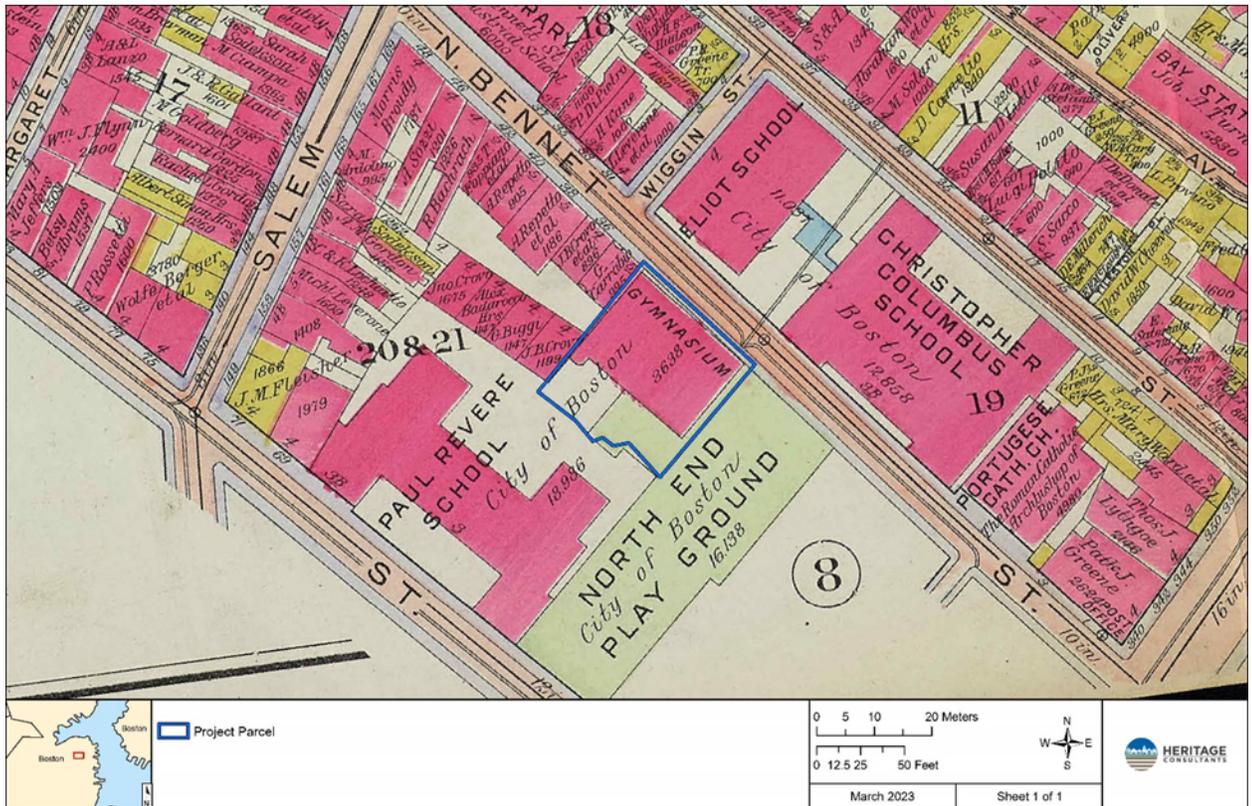
Figure 33. 1908 map with gymnasium on North Bennet Street.

The building the city constructed at 30–32 Bennet Street was both a bathhouse and a gymnasium, as shown on the 1908 Boston atlas map (Figure 10).¹⁴ It should be noted that documents of the period can cause some confusion for modern-day readers because people of the time tended to use the term “bathing” interchangeably for both recreational swimming and taking baths for personal hygiene. This building accommodated only the hygiene version of baths. The city’s decision to build such a structure is related to its late-19th- and early 20th-century public health policies and programs, as well as to the type of neighborhood the North End was and remains today. Figure 9 and Figure 17 illustrate the neighborhood’s densely crowded conditions, with little open space and buildings fronting directly on the streets.¹⁵ The combined effects of industrialization, urbanization, and poverty during the 19th century contributed to high rates of endemic and epidemic disease in Boston and throughout the North End. In response, Boston’s leaders implemented a series of

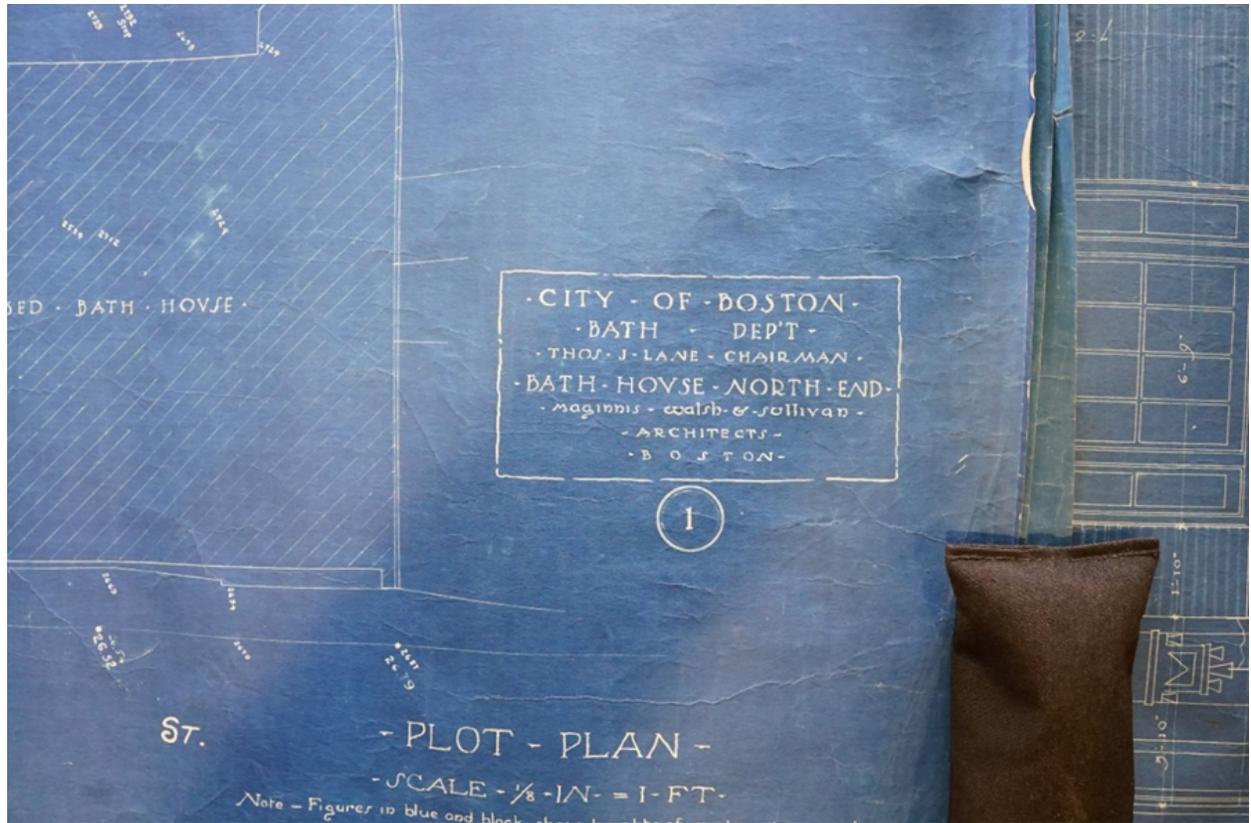
Figure 40. Architectural plans dated 1903 for “Bath House North End.”

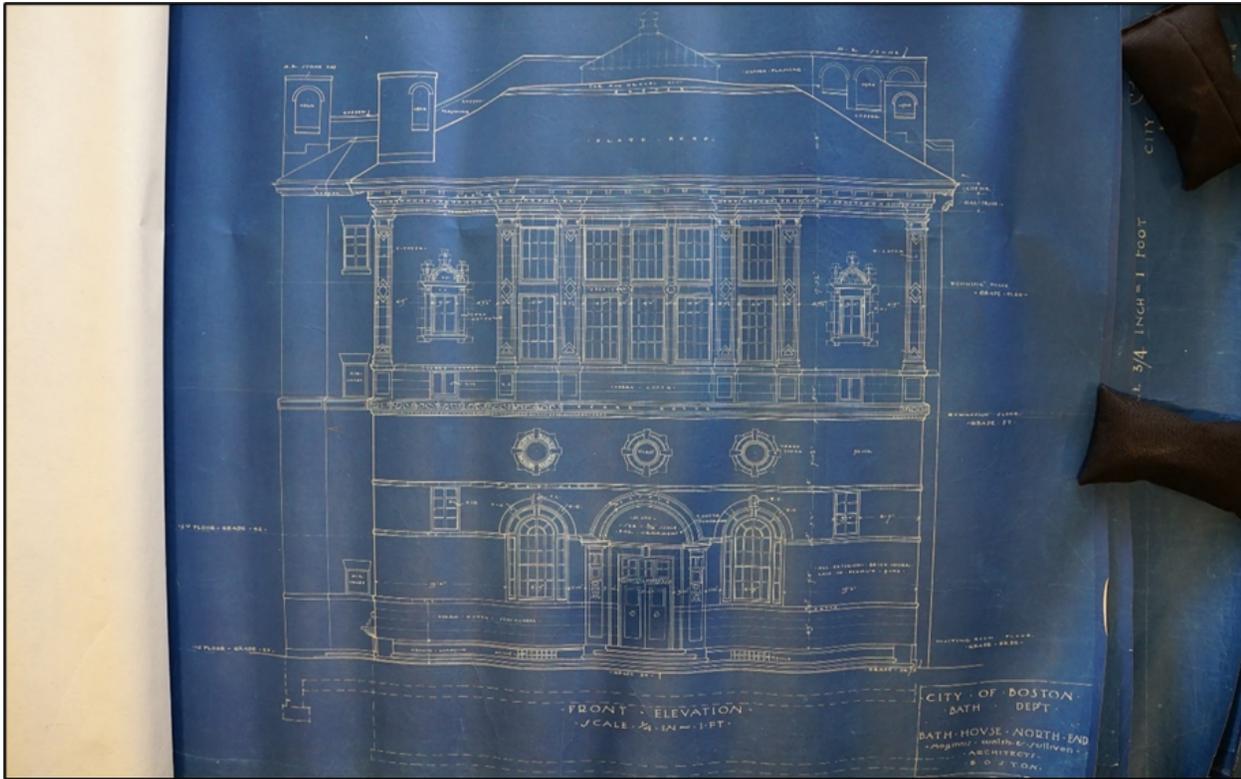
Figure 41. 1903 architectural plans labeled “Front Elevation.”

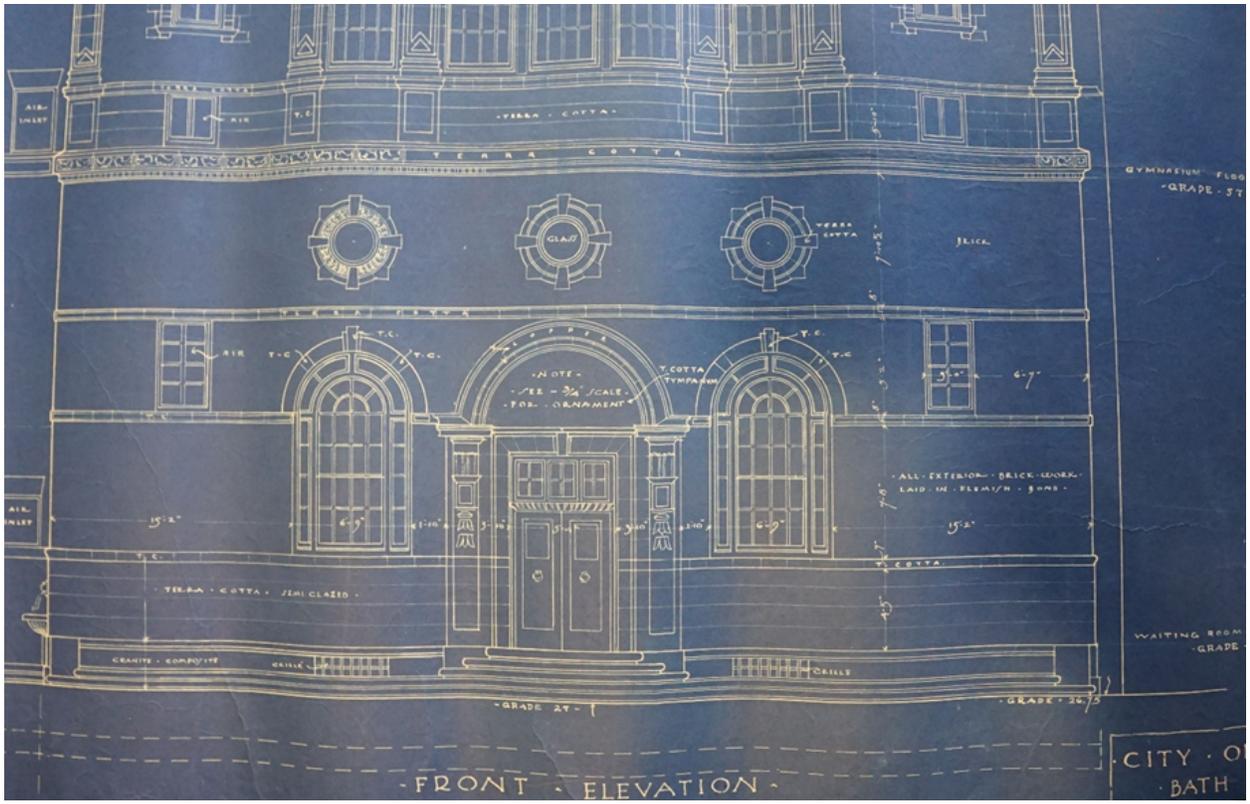
Figure 42. 1903 architectural plans, detail of front elevation, lower level.

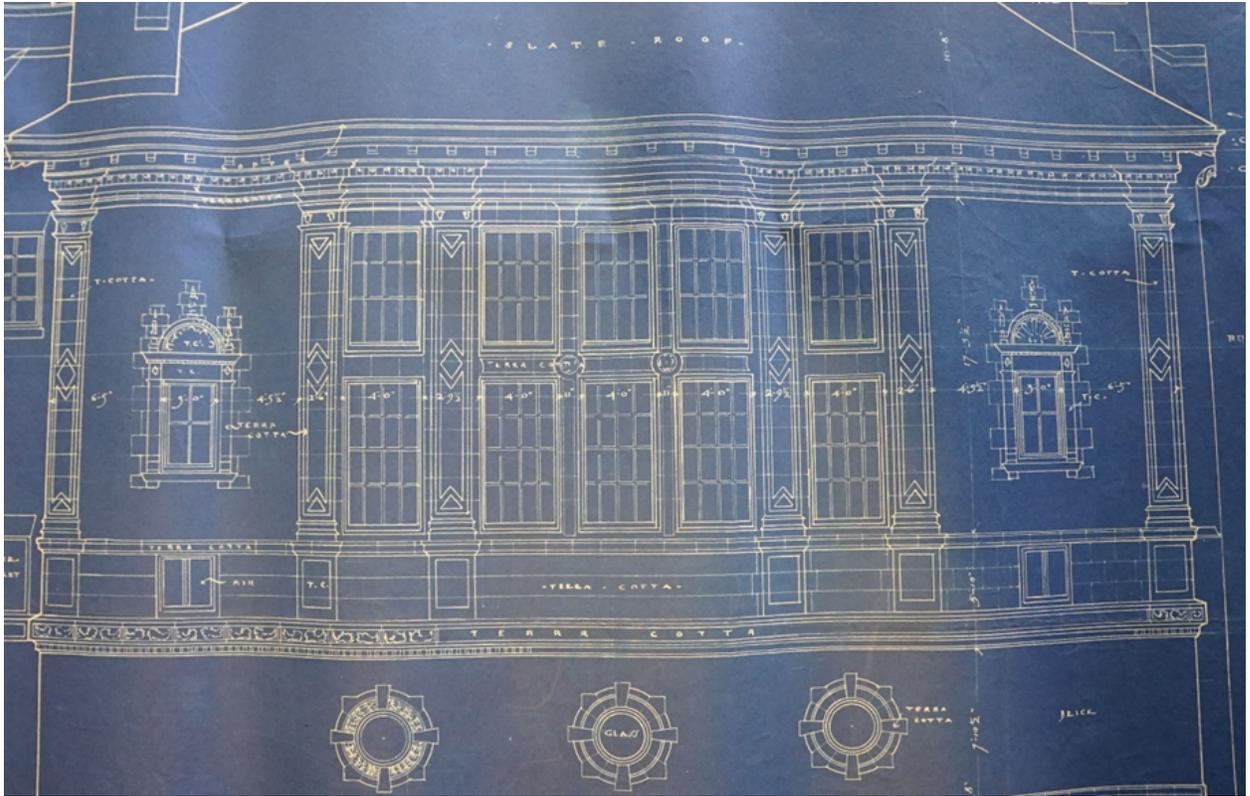
Figure 43. Detail of front elevation upper levels on 1903 architectural plans.

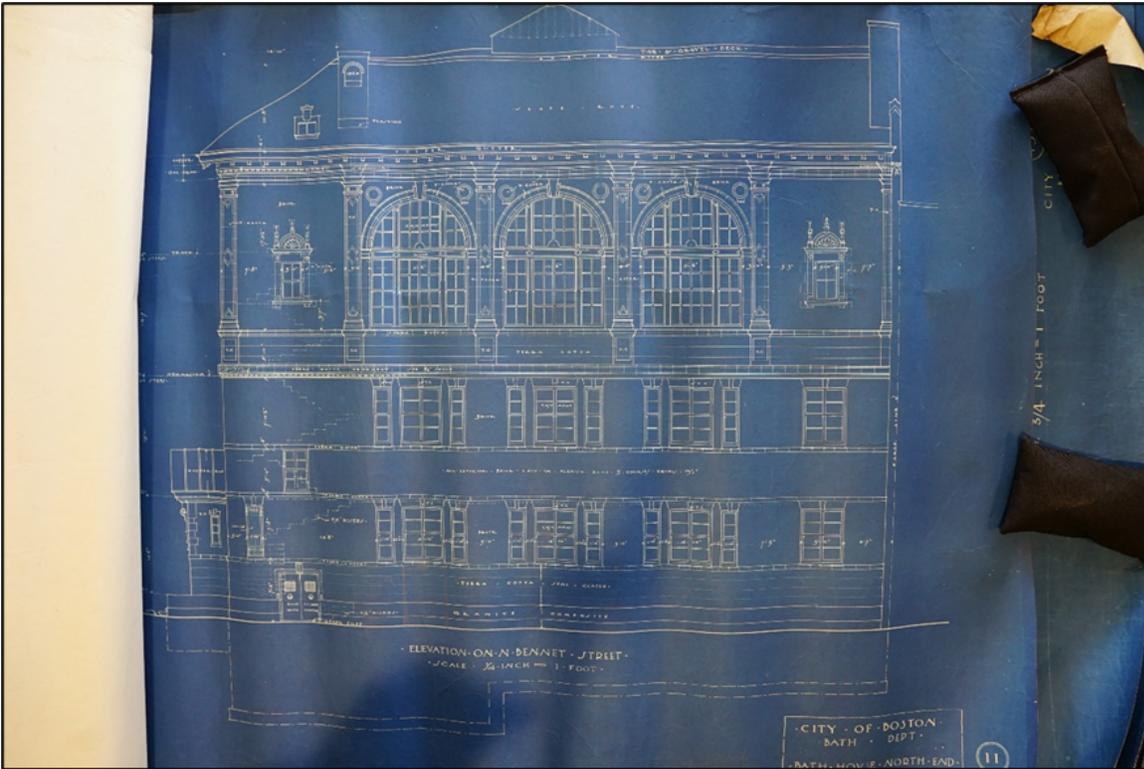
Figure 44. 1903 Architectural plans, North Bennet Street elevation.

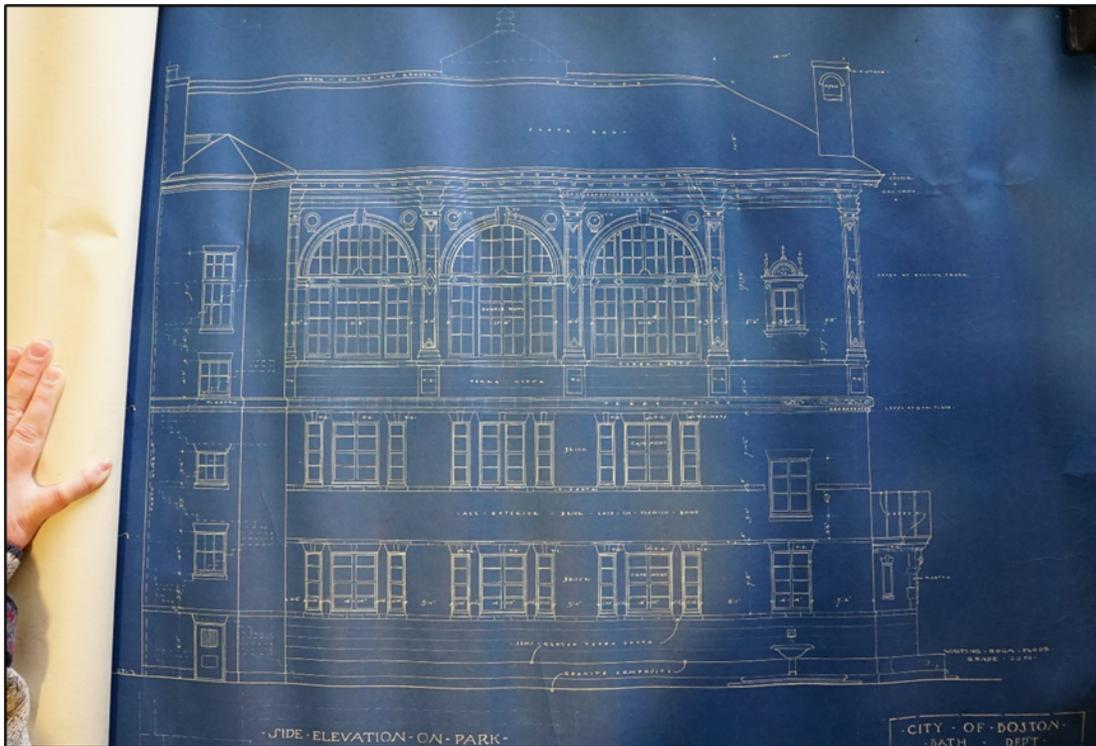
Figure 45. 1903 architectural plans of the Park Side elevation.

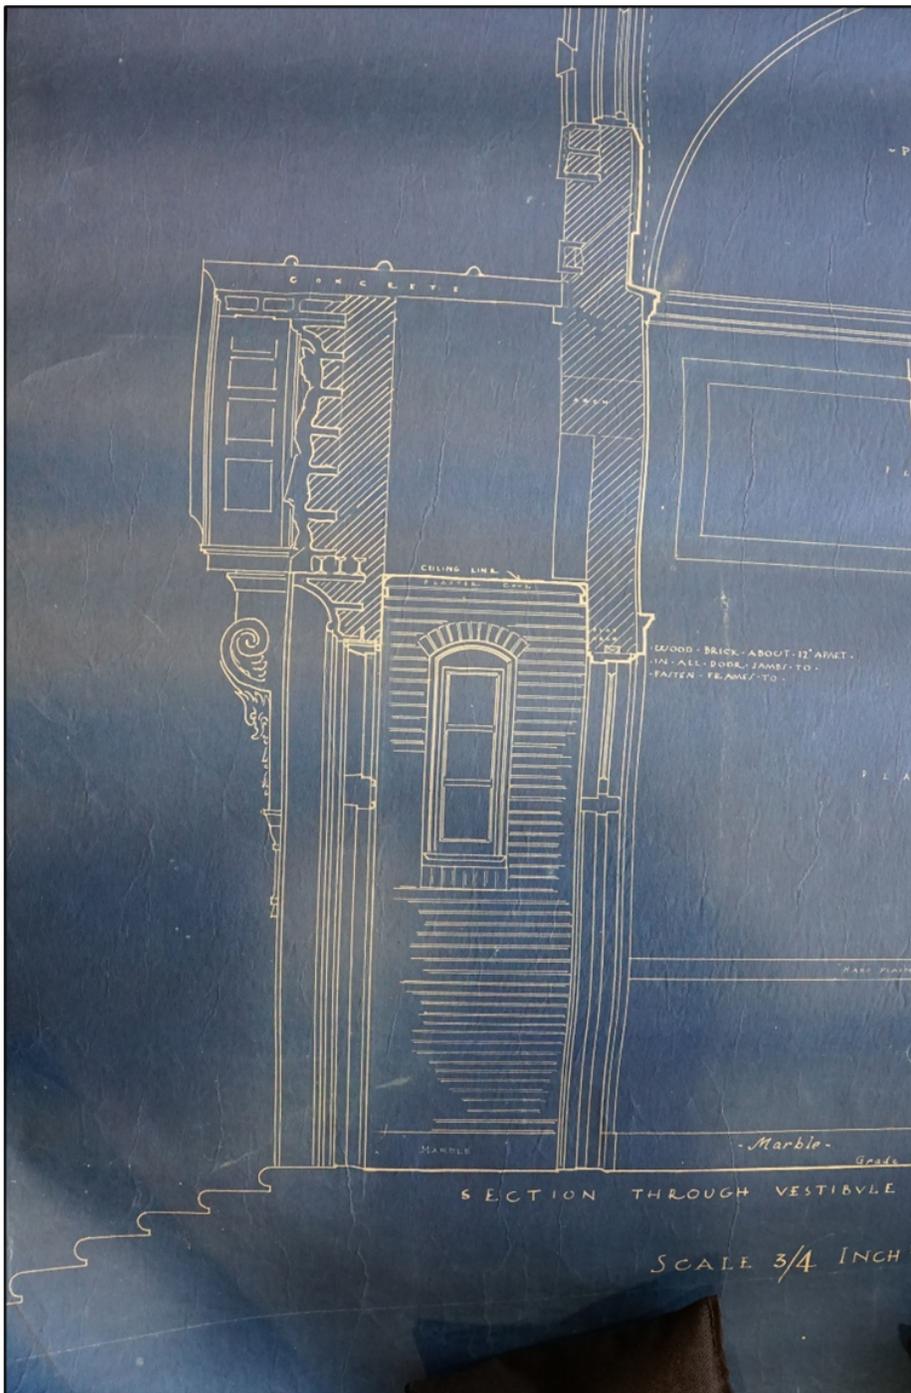
Figure 46. 1903 architectural plan of vestibule.
